EIGHT FORMS OF CORROSION

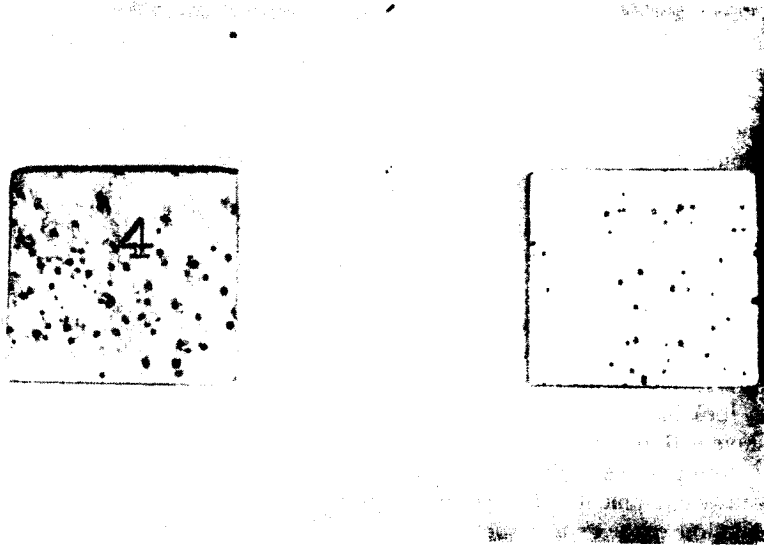
Figure 3-14 Pitting of 18-8 stainless steel by acid-chloride solution.

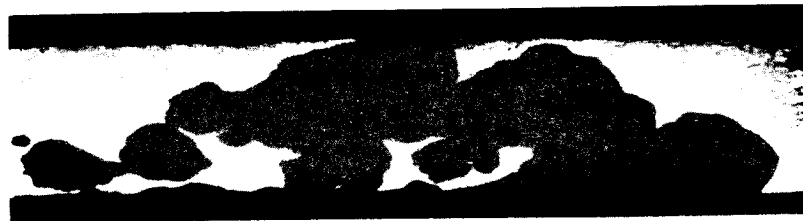
Figure 3-16 Pitting of stainless steel condenser tube.

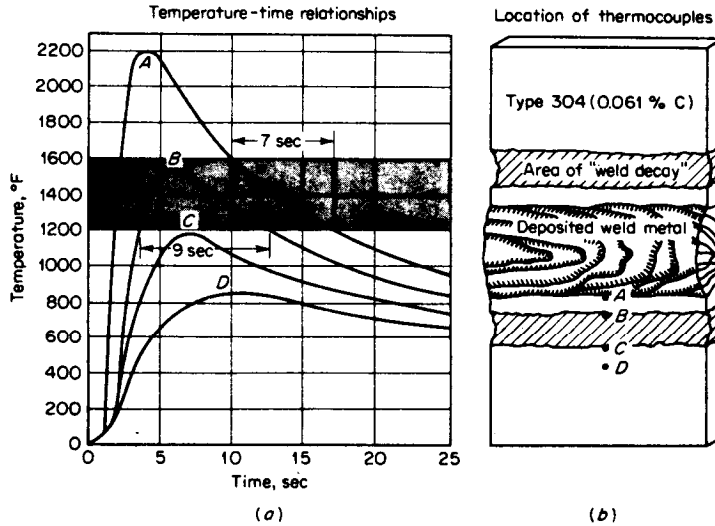
Figure 3-29 Temperatures during electric-arc welding of type 304 stainless steel. (Du Pont Company)

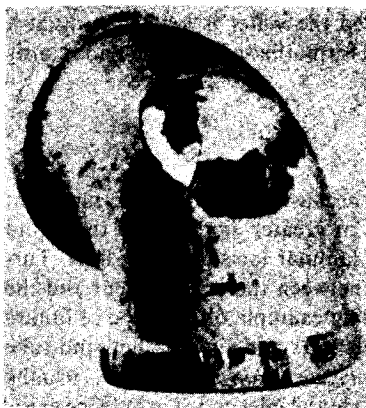
Figure 3-45 Impingement failure of elbow in steam condensate line.

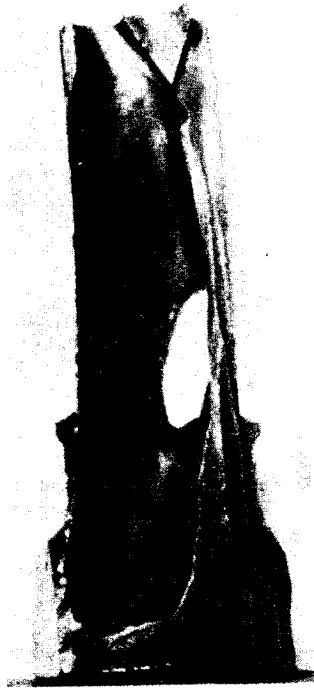
Figure 3-46 Erosion corrosion of slide valve at 900°F in petroleum refinery.

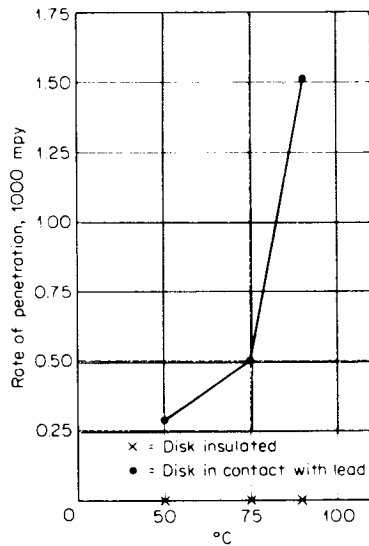
Figure 3-48 Effect of contact with lead on erosion corrosion of type 316 by 10% sulfuric acid (velocity, 39 ft/sec).

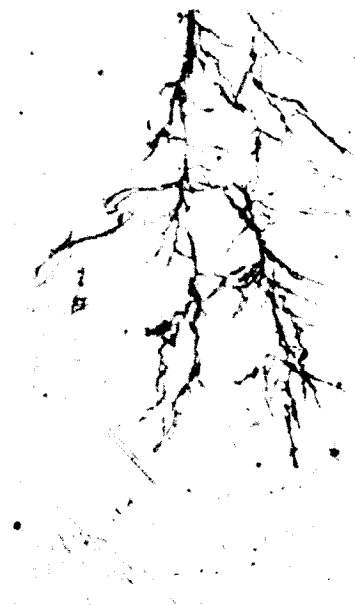
Figure 3-53 Cross section of stress-corrosion crack in stainless steel (500 \times).

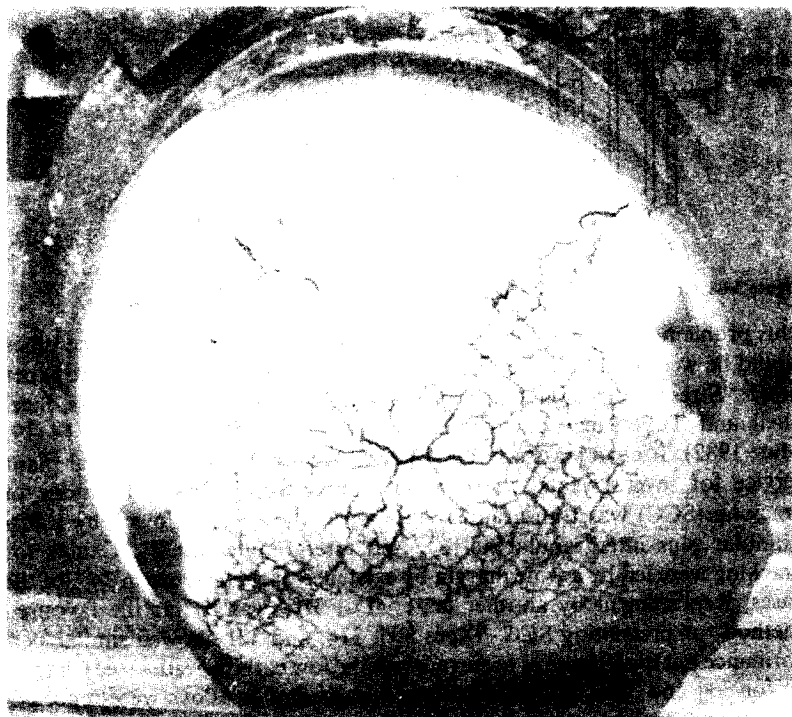
Figure 3-66 Stress corrosion of type 304 autoclave. (Mallinckrodt Chemical Works)

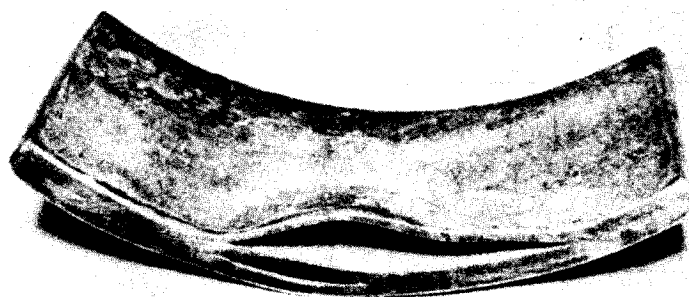
Figure 3-75 Cross section of a carbon steel plate removed from a petroleum process stream showing a large hydrogen blister. Exposure time: 2 years. (*Imperial Oil Limited, Ontario, Canada*)
